Infrared Energy Report

John Jones
5 Anytown Rd.
Anytown, NJ 08892

Sunday, September 23, 2012

Survey Report #: 201208
Survey date: 8/20/2012
Weather: Partly Cloudy
Outdoor temperature: 83
Indoor temperature: 75
Temp diff In-Out (Δt): 8

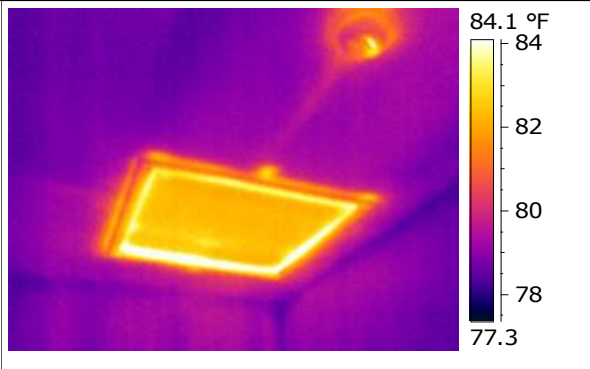
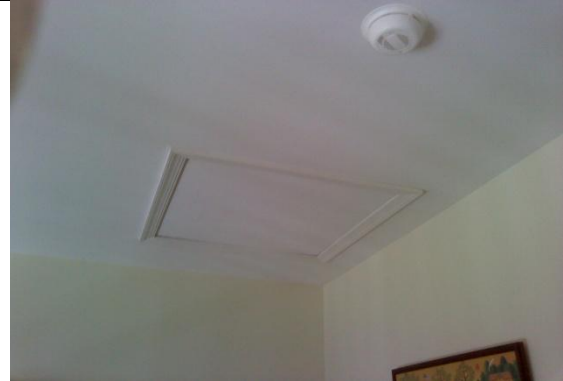
Image.File name IR_2320.jpg

LOCATION: Loft

WHERE: Ceiling

CONDITION: Uninsulated attic stairs or hatch

RECOMMENDATION: Installing an insulated box/cover over opening is recommended

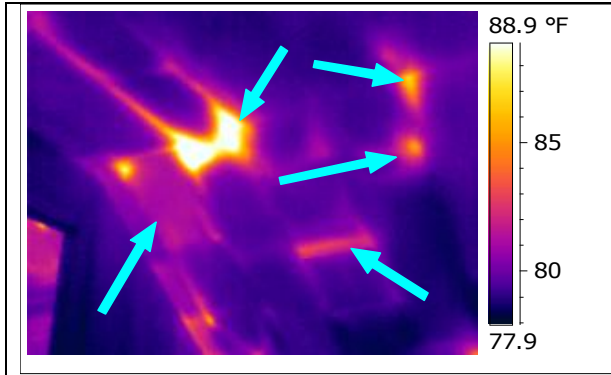
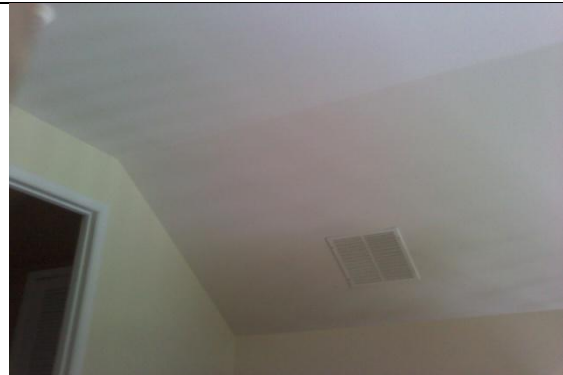
Image.File name IR_2322.jpg

LOCATION: Loft

WHERE: Ceiling

CONDITION: The thermal pattern, brighter areas, is indicative of missing insulation/air leakage

RECOMMENDATION: Installing additional insulation and air sealing is recommended

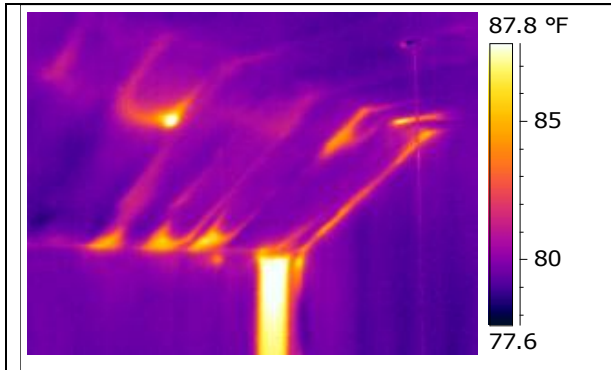
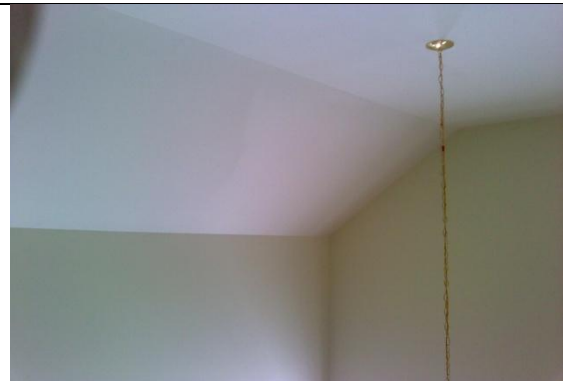
Image.File name IR_2324.jpg

LOCATION: Dining Room

WHERE: Ceiling

CONDITION: The thermal pattern, bright areas, is indicative of insufficient or missing insulation

RECOMMENDATION: Suggest installing additional blown-in insulation to R-50

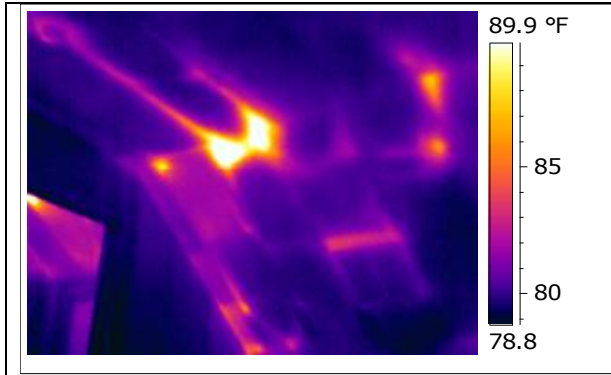
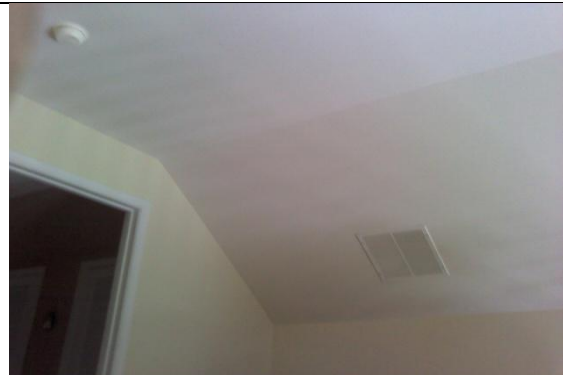
Image.File name IR_2326.jpg

LOCATION: Loft
 WHERE: Ceiling
 CONDITION: The thermal pattern is indicative of insufficient or missing insulation
 RECOMMENDATION: Suggest installing additional blown-in insulation to R-50
 COMMENTS:

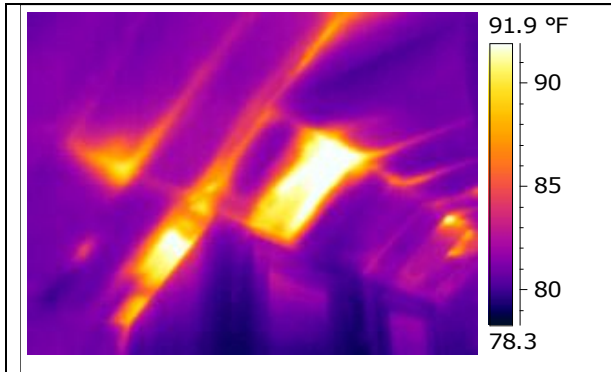
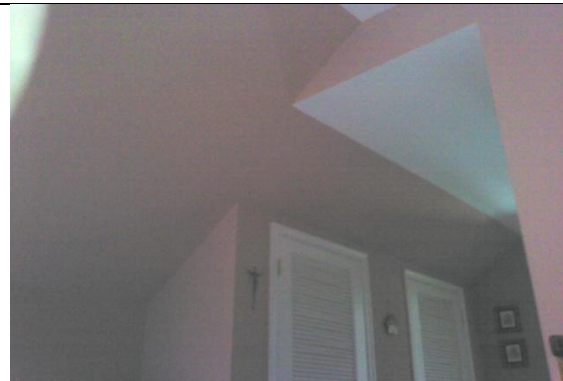
Image.File name IR_2328.jpg

LOCATION: Loft
 WHERE: Ceiling
 CONDITION: The thermal pattern, bright areas, is indicative of insufficient or missing insulation
 RECOMMENDATION: Suggest installing additional blown-in insulation to R-50
 COMMENTS:

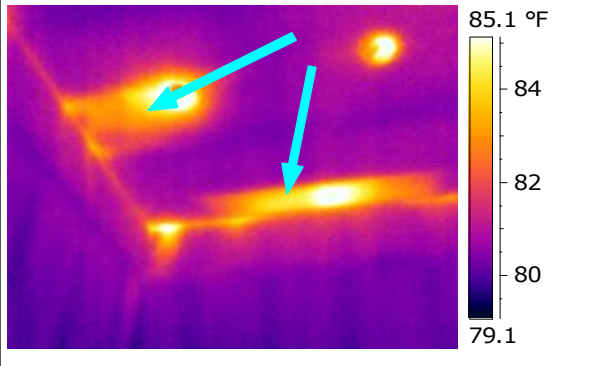
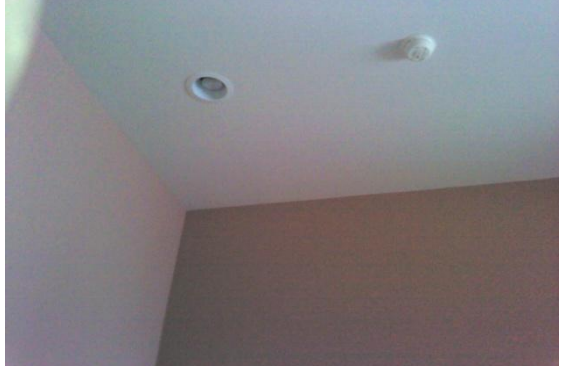
Image.File name IR_2330.jpg	Image.Date 8/20/2012 Image.Time 1:47:13 PM
<p>LOCATION: Loft WHERE: Ceiling CONDITION: The thermal pattern is indicative of insufficient or missing insulation RECOMMENDATION: Suggest installing additional blown-in insulation to R-50 COMMENTS:</p>

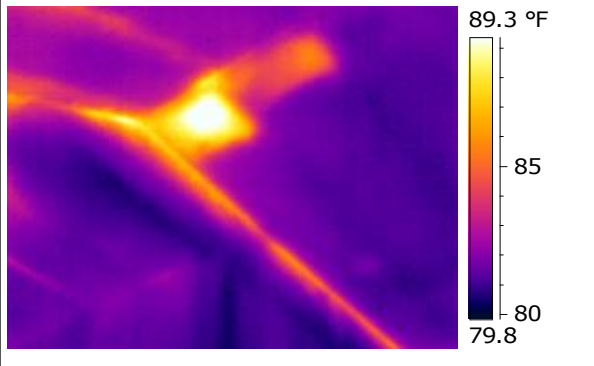
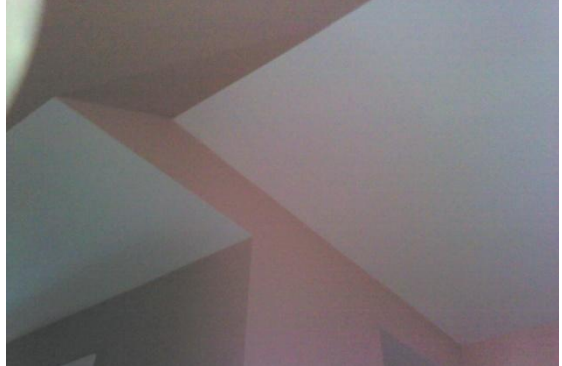
Image.File name IR_2332.jpg	Image.Date 8/20/2012 Image.Time 1:47:47 PM
<p>LOCATION: Loft WHERE: Ceiling CONDITION: The thermal pattern is indicative of missing insulation/air leakage RECOMMENDATION: Installing additional insulation and air sealing is recommended COMMENTS: The preceding photo's indicate poor installation of insulation during construction. These conditions will lead to high heating and cooling bills. It is recommended a qualified insulation contractor make repairs and have the home re-inspected.</p>

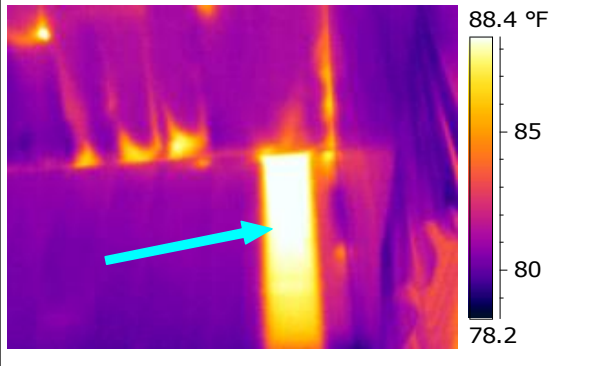
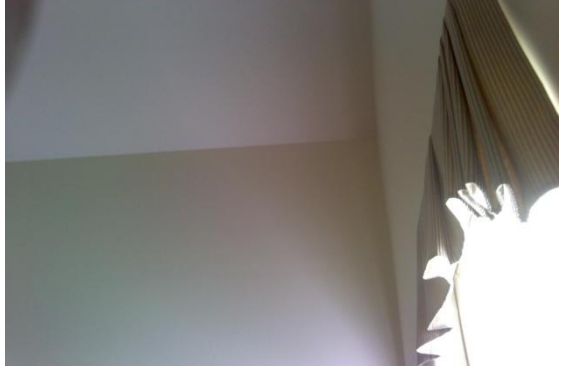
Image.File name IR_2334.jpgg	Image.Date 8/20/2012 Image.Time 1:50:37 PM
<p>LOCATION: Dining Room WHERE: Front Wall CONDITION: The thermal pattern is indicative of missing insulation in the wall cavity RECOMMENDATION: Have a insulation contractor blow in insulation COMMENTS:</p>

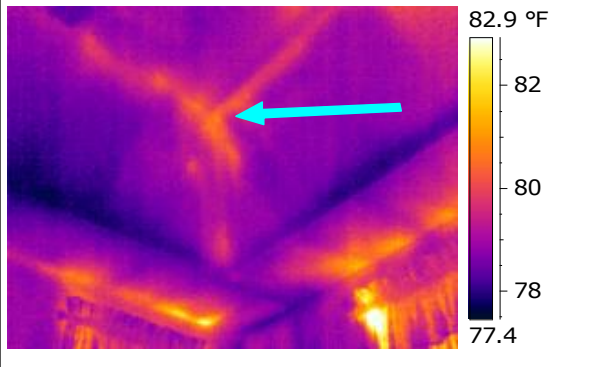
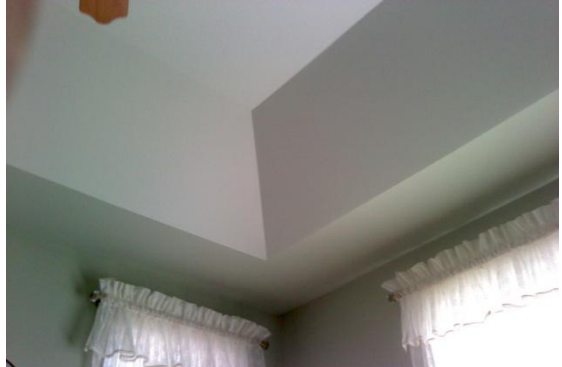
Image.File name IR_2338.jpgg	Image.Date 8/20/2012 Image.Time 1:52:20 PM
<p>LOCATION: Master Bedroom WHERE: Ceiling CONDITION: The thermal pattern is indicative of insufficient or missing insulation RECOMMENDATION: Suggest installing additional blown-in insulation to R-50 COMMENTS:</p>

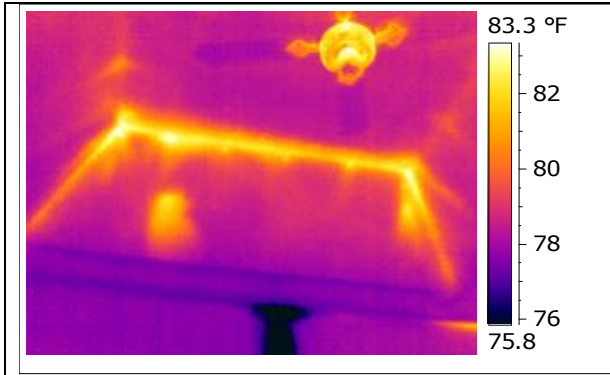
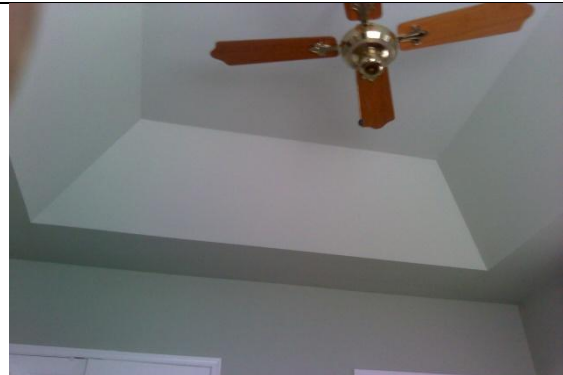
Image.File name IR_2340.jpg

LOCATION: Master Bedroom
 WHERE: Ceiling
 CONDITION: The thermal pattern, bright areas, is indicative of insufficient or missing insulation
 RECOMMENDATION: Suggest installing additional blown-in insulation to R-50
 COMMENTS:

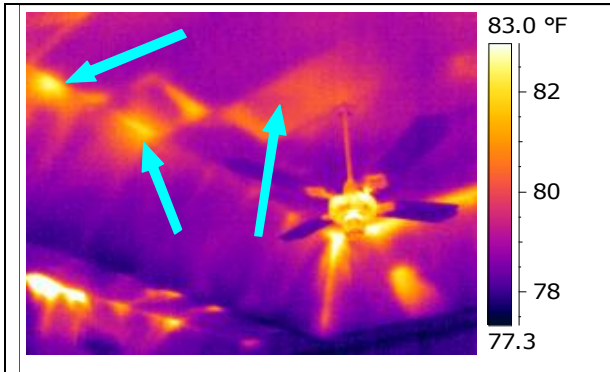
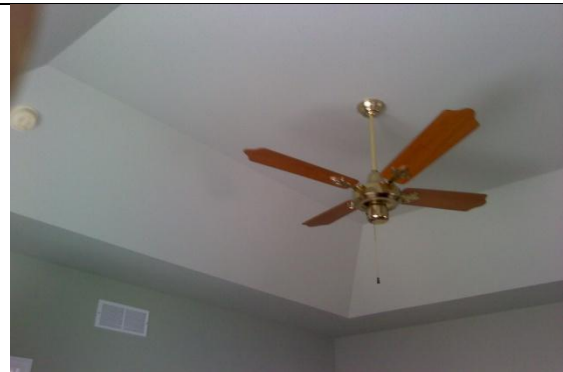
Image.File name IR_2342.jpg

LOCATION: Master Bedroom
 WHERE: Ceiling
 CONDITION: The thermal pattern, bright areas, is indicative of insufficient or missing insulation
 RECOMMENDATION: Suggest installing additional blown-in insulation to R-50
 COMMENTS:

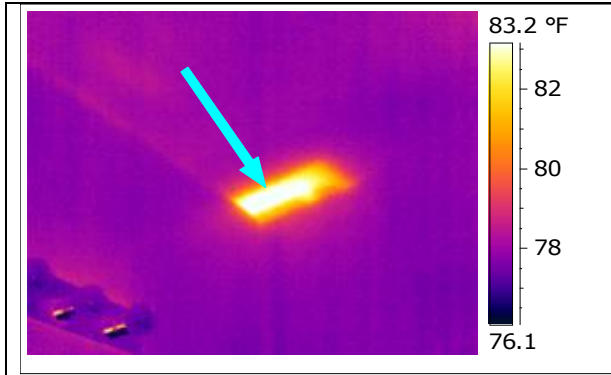
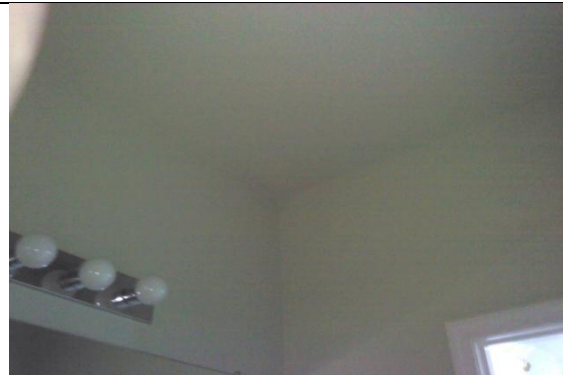
Image.File name IR_2344.jpg

LOCATION: Master bathroom
 WHERE: Ceiling
 CONDITION: The thermal pattern is indicative of missing insulation
 RECOMMENDATION: Suggest installing additional blown-in insulation to R-50
 COMMENTS:

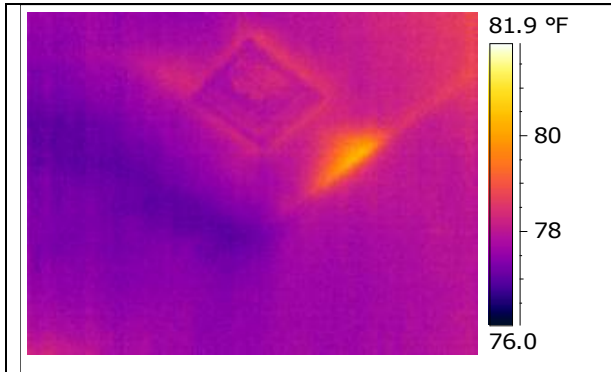
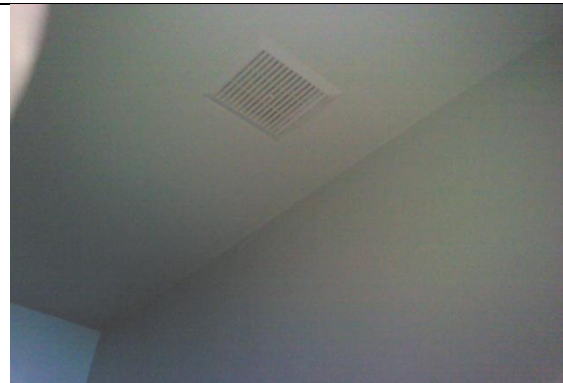
Image.File name IR_2346.jpg

LOCATION: Master bathroom
 WHERE: Ceiling
 CONDITION: The thermal pattern is indicative of missing insulation
 RECOMMENDATION: Suggest adding additional insulation
 COMMENTS:

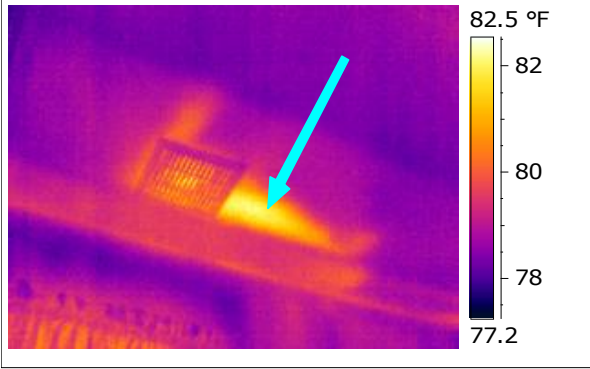
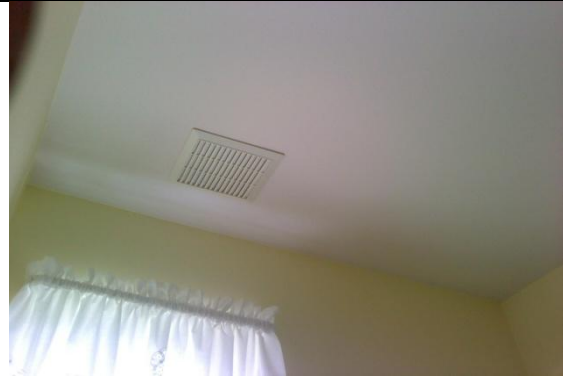
Image.File name IR_2348.jpg

LOCATION: Half Bathroom
WHERE: Ceiling
CONDITION: The thermal pattern is indicative of missing insulation
RECOMMENDATION: Suggest adding additional insulation
COMMENTS:
