## Infrared Energy Report

John Jones  
5 Anytown Rd.  
Anytown, NJ 08892

Sunday, September 23, 2012

Survey Report #: 201208  
Survey date: 8/20/2012  
Weather: Partly Cloudy  
Outdoor temperature: 83  
Indoor temperature: 75  
Temp diff In-Out ( $\Delta t$ ): 8

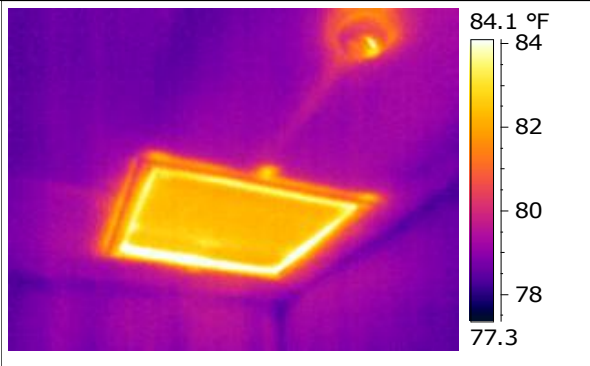
Image.File name IR\_2320.jpg

LOCATION: Loft

WHERE: Ceiling

CONDITION: Uninsulated attic stairs or hatch

RECOMMENDATION: Installing an insulated box/cover over opening is recommended

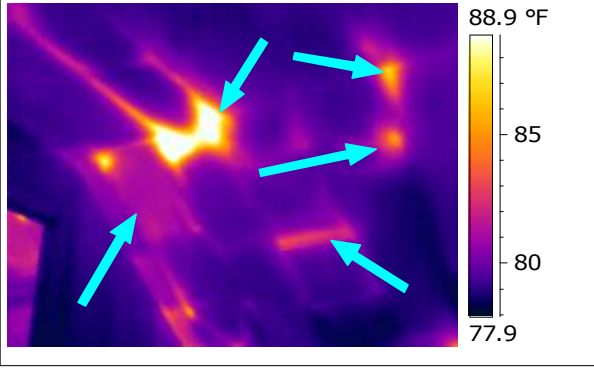
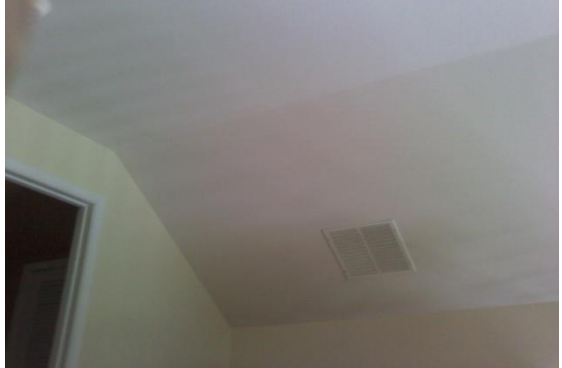
<b>Image.File name IR_2322.jpg</b>	<b>Image.Date 8/20/2012 Image.Time 1:44:35 PM</b>
<p>LOCATION: Loft          WHERE: Ceiling          CONDITION: The thermal pattern, brighter areas, is indicative of missing insulation/air leakage          RECOMMENDATION: Installing additional insulation and air sealing is recommended          COMMENTS:</p>

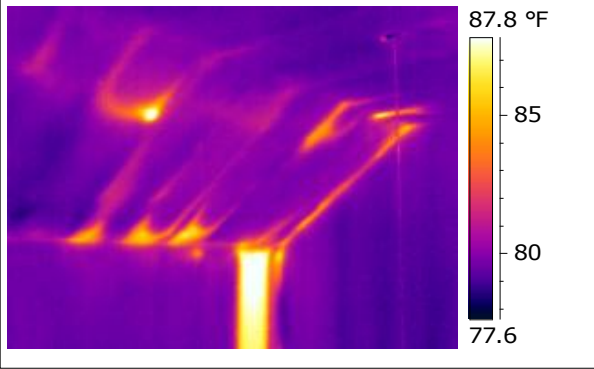
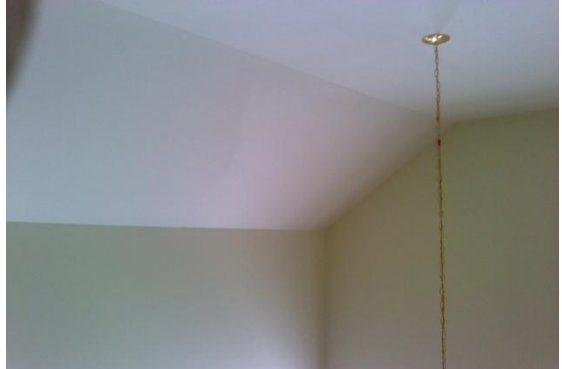
<b>Image.File name IR_2324.jpg</b>	<b>Image.Date 8/20/2012 Image.Time 1:45:13 PM</b>
<p>LOCATION: Dining Room          WHERE: Ceiling          CONDITION: The thermal pattern, bright areas, is indicative of insufficient or missing insulation          RECOMMENDATION: Suggest installing additional blown-in insulation to R-50          COMMENTS:</p>

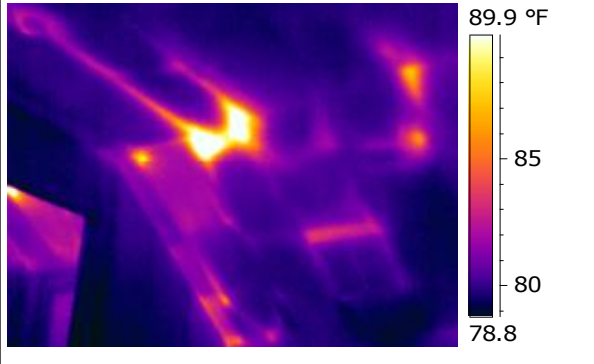
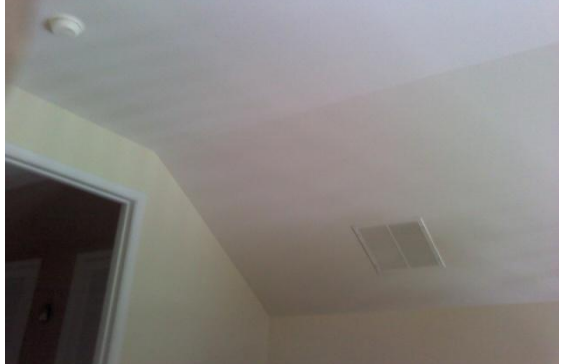
<p><b>Image.File name</b> IR_2326.jpg</p>	<p><b>Image.Date</b> 8/20/2012 <b>Image.Time</b> 1:45:49 PM</p>

LOCATION: Loft  
 WHERE: Ceiling  
 CONDITION: The thermal pattern is indicative of insufficient or missing insulation  
 RECOMMENDATION: Suggest installing additional blown-in insulation to R-50  
 COMMENTS:

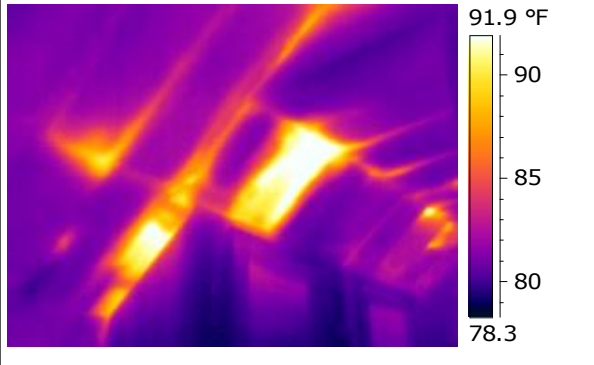
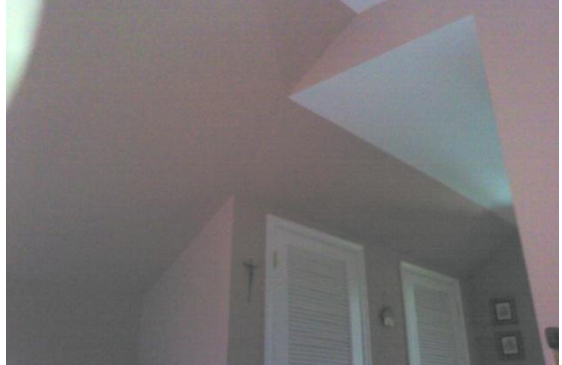
<p><b>Image.File name</b> IR_2328.jpg</p>	<p><b>Image.Date</b> 8/20/2012 <b>Image.Time</b> 1:46:34 PM</p>

LOCATION: Loft  
 WHERE: Ceiling  
 CONDITION: The thermal pattern, bright areas, is indicative of insufficient or missing insulation  
 RECOMMENDATION: Suggest installing additional blown-in insulation to R-50  
 COMMENTS:

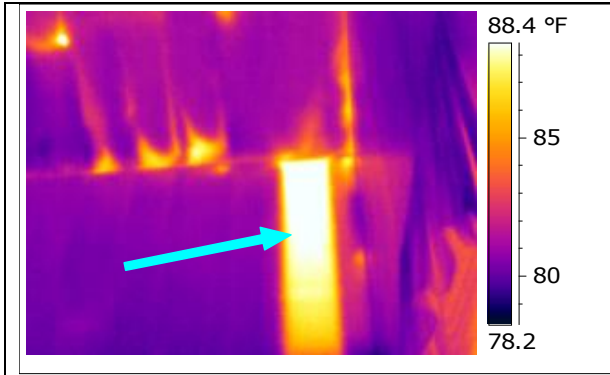
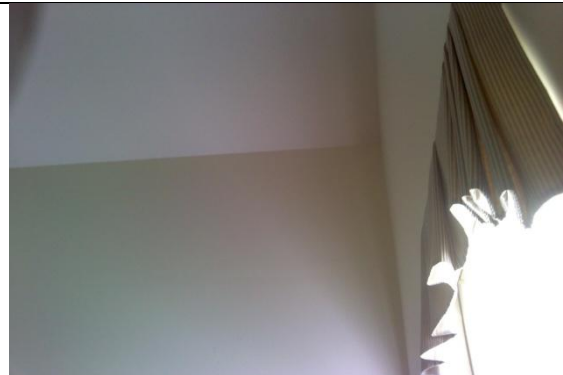
Image.File name IR\_2334.jpg

LOCATION: Dining Room  
 WHERE: Front Wall  
 CONDITION: The thermal pattern is indicative of missing insulation in the wall cavity  
 RECOMMENDATION: Have a insulation contractor blow in insulation  
 COMMENTS:

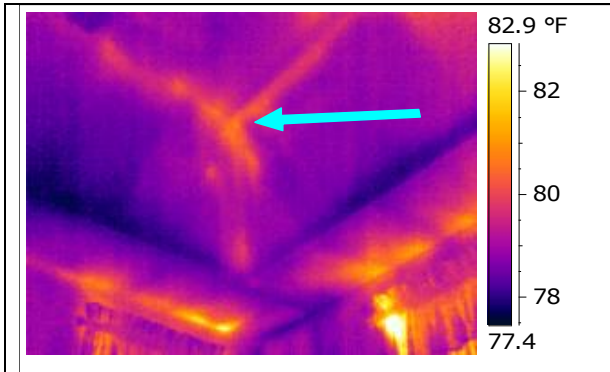
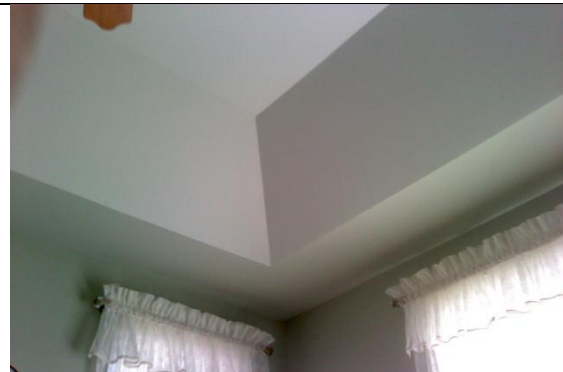
Image.File name IR\_2338.jpg

LOCATION: Master Bedroom  
 WHERE: Ceiling  
 CONDITION: The thermal pattern is indicative of insufficient or missing insulation  
 RECOMMENDATION: Suggest installing additional blown-in insulation to R-50  
 COMMENTS:

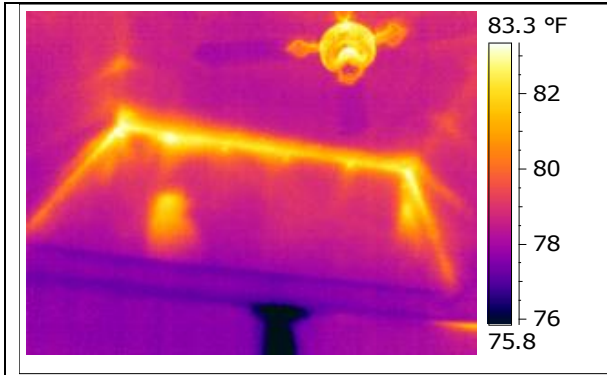
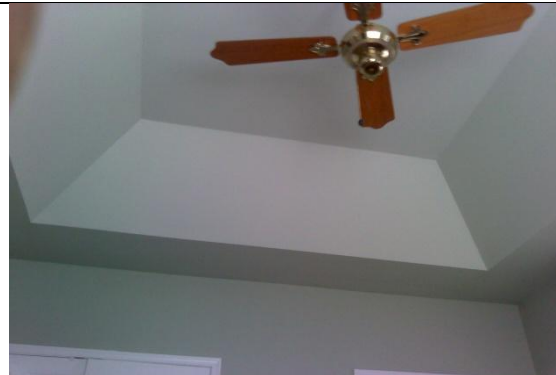
Image.File name IR\_2340.jpg

LOCATION: Master Bedroom  
 WHERE: Ceiling  
 CONDITION: The thermal pattern, bright areas, is indicative of insufficient or missing insulation  
 RECOMMENDATION: Suggest installing additional blown-in insulation to R-50  
 COMMENTS:

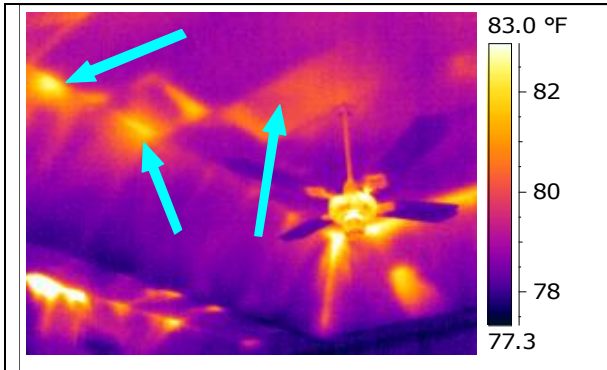
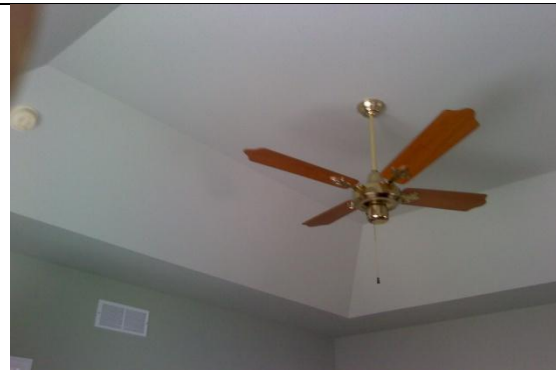
Image.File name IR\_2342.jpg

LOCATION: Master Bedroom  
 WHERE: Ceiling  
 CONDITION: The thermal pattern, bright areas, is indicative of insufficient or missing insulation  
 RECOMMENDATION: Suggest installing additional blown-in insulation to R-50  
 COMMENTS:
