## Infrared Energy Report

Rouser Way  
Hillsborough, NJ 08844

March 11, 2012

Survey Report #: 20120311SAM  
Survey date: 3/11/2012

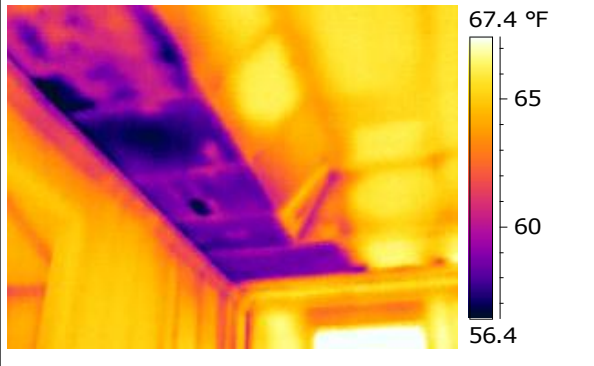
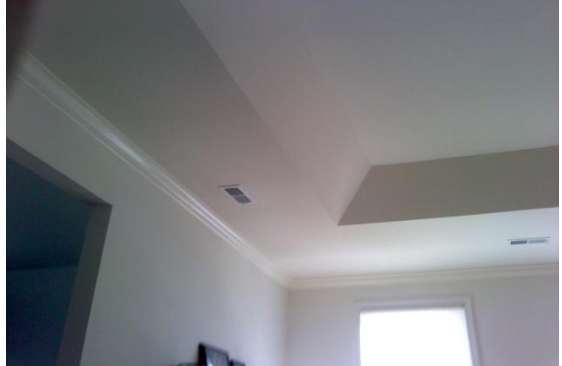
<p><b>Image.File name</b> IR_1030.jpg</p>	<p><b>Image.Date</b> 3/10/2012 <b>Image.Time</b> 10:25:33 AM</p>
<p>LOCATION: Master Bedroom          WHERE: Ceiling          CONDITION: The thermal pattern, Darker areas, is indicative of insufficient/missing insulation          RECOMMENDATION: Suggest adding additional insulation          COMMENTS:</p>

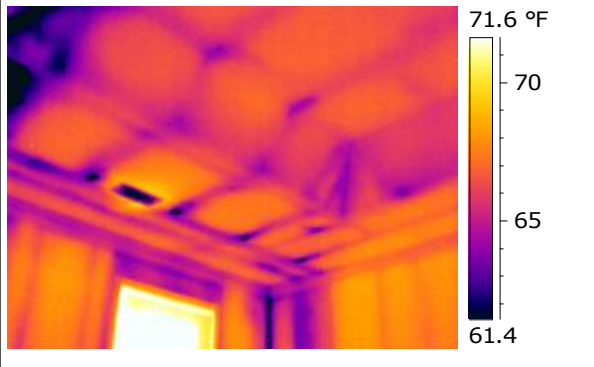
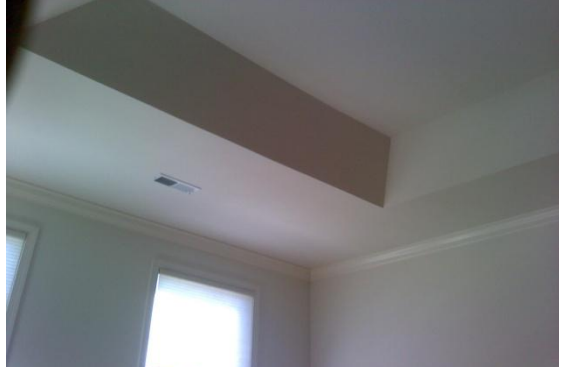
<p><b>Image.File name</b> IR_1032.jpg</p>	<p><b>Image.Date</b> 3/10/2012 <b>Image.Time</b> 10:26:42 AM</p>
<p>LOCATION: Master Bedroom          WHERE: Ceiling          CONDITION: The thermal pattern, Darker areas, is indicative of insufficient/missing insulation          RECOMMENDATION: Suggest adding additional insulation          COMMENTS:</p>

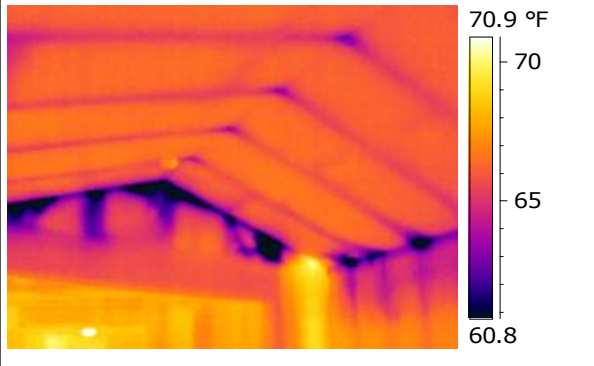
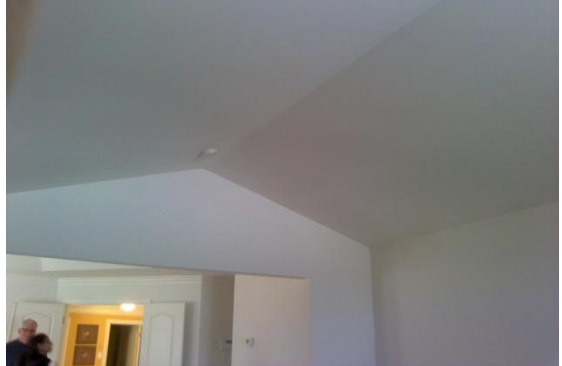
<p><b>Image.File name IR_1034.jpg</b></p>	<p><b>Image.Date 3/10/2012 Image.Time 10:28:45 AM</b></p>

LOCATION: Master Bedroom  
 WHERE: Wall and ceiling junction  
 CONDITION: The thermal pattern, darker areas, is indicative of missing insulation/air leakage  
 RECOMMENDATION: Installing additional insulation and air sealing is recommended  
 COMMENTS:

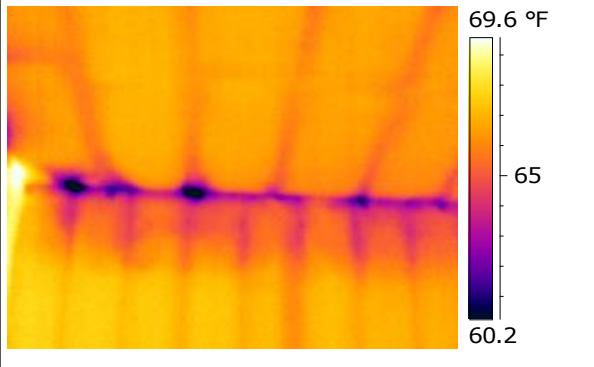
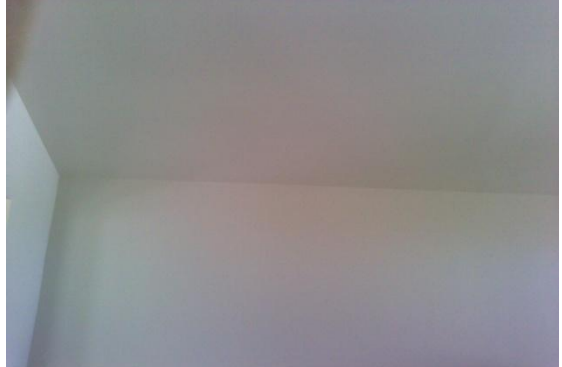
<p><b>Image.File name IR_1038.jpg</b></p>	<p><b>Image.Date 3/10/2012 Image.Time 10:29:49 AM</b></p>

LOCATION: Master Bedroom  
 WHERE: Wall and ceiling junction  
 CONDITION: The thermal pattern, darker areas, is indicative of missing insulation/air leakage  
 RECOMMENDATION: Installing additional insulation and air sealing is recommended  
 COMMENTS:

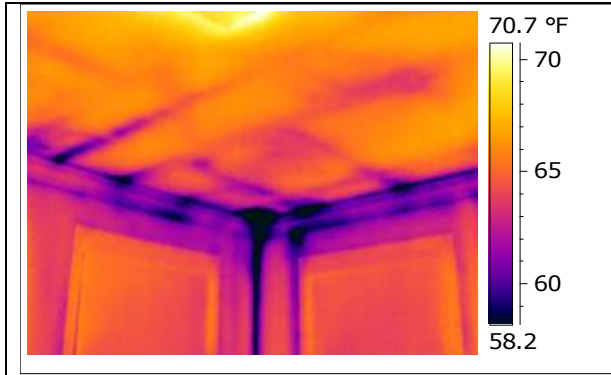
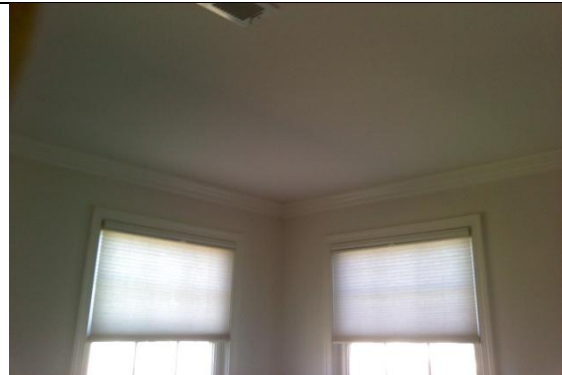
Image.File name IR\_1040.jpg

LOCATION: Master bathroom  
 WHERE: Wall and ceiling junction  
 CONDITION: The thermal pattern, darker areas, is indicative of missing insulation/air leakage  
 RECOMMENDATION: Installing additional insulation and air sealing is recommended  
 COMMENTS:

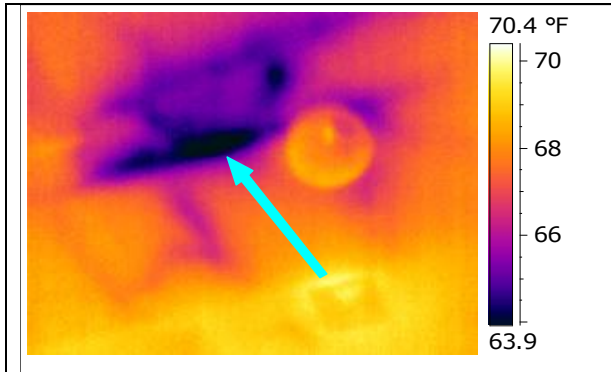
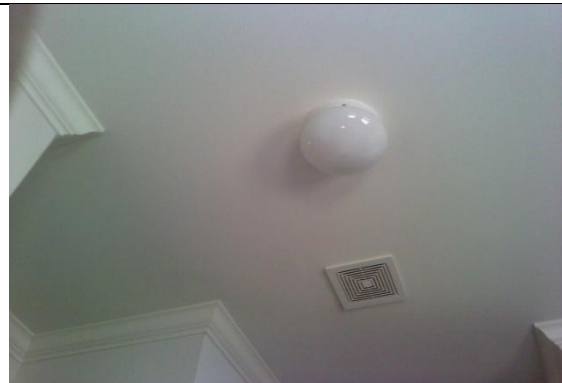
Image.File name IR\_1042.jpg

LOCATION: Master bathroom  
 WHERE: Ceiling  
 CONDITION: The thermal pattern, Darker areas, is indicative of insufficient/missing insulation  
 RECOMMENDATION: Suggest installing additional blown-in insulation to R-50  
 COMMENTS:

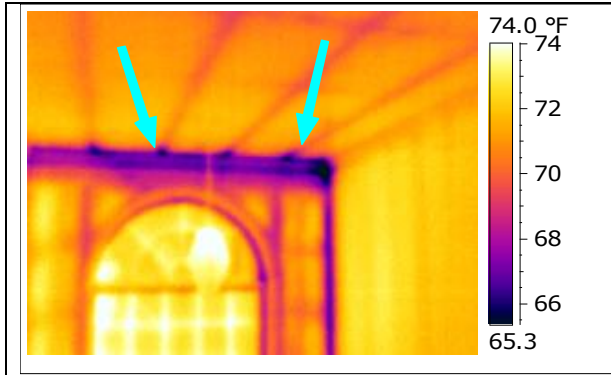
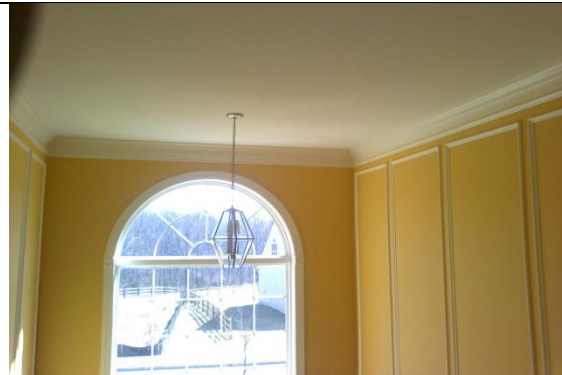
Image.File name IR\_1044.jpg

LOCATION: Entry  
 WHERE: Wall and ceiling junction  
 CONDITION: The thermal pattern, darker areas, is indicative of missing insulation/air leakage  
 RECOMMENDATION: Installing additional insulation and air sealing is recommended  
 COMMENTS:

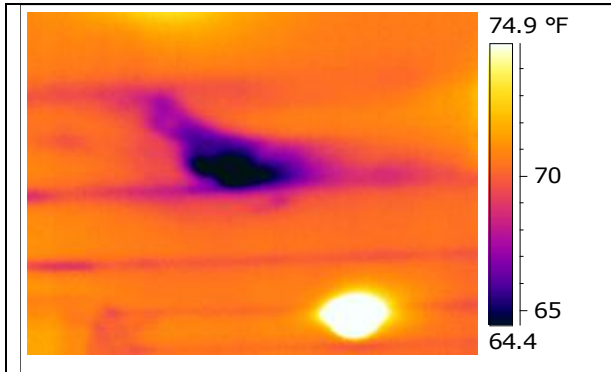
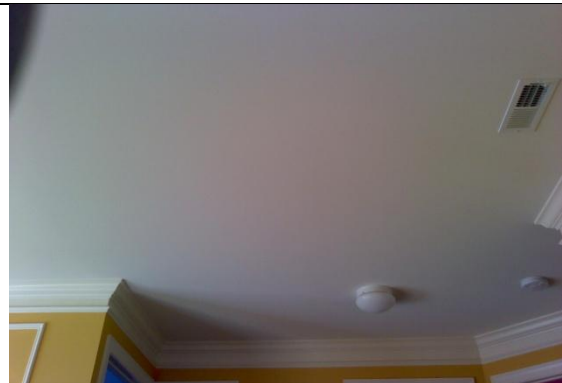
Image.File name IR\_1046.jpg

LOCATION: Hallway Upper  
 WHERE: Ceiling  
 CONDITION: The thermal pattern, darker areas, is indicative of missing insulation  
 RECOMMENDATION: Suggest installing additional blown-in insulation to R-50  
 COMMENTS:

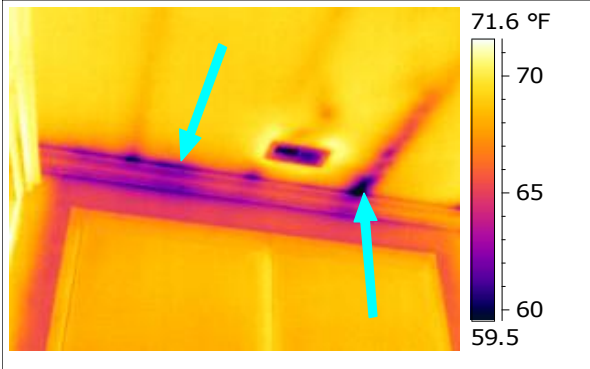
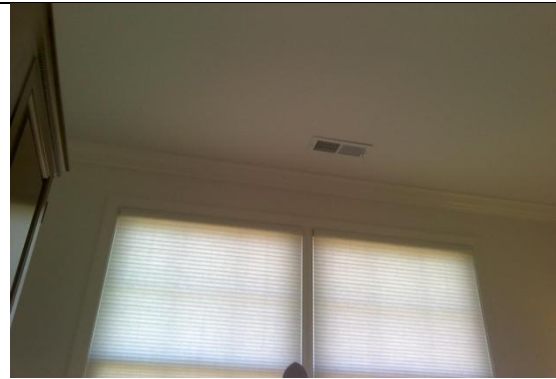
**Image.File name IR\_1048.jpg**

LOCATION: Rear Center Bedroom

WHERE: Wall and ceiling junction

CONDITION: The thermal pattern, darker areas, is indicative of missing insulation/air leakage

RECOMMENDATION: Installing additional insulation and air sealing is recommended

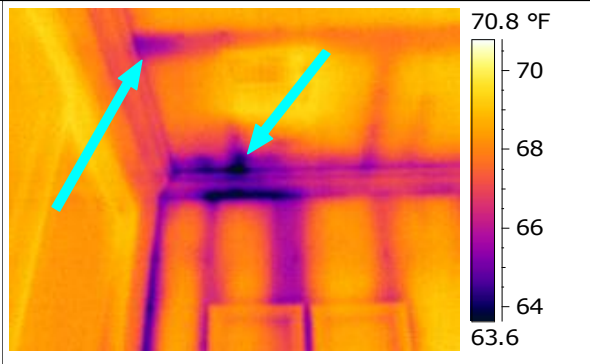
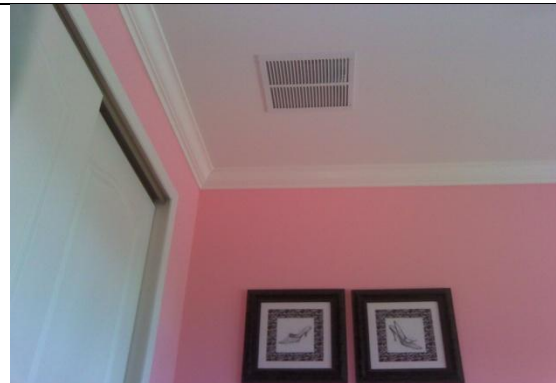
**Image.File name IR\_1050.jpg**

LOCATION: Rear Left Bedroom

WHERE: Ceiling

CONDITION: The thermal pattern, darker areas, is indicative of missing insulation/air leakage

RECOMMENDATION: Installing additional insulation and air sealing is recommended

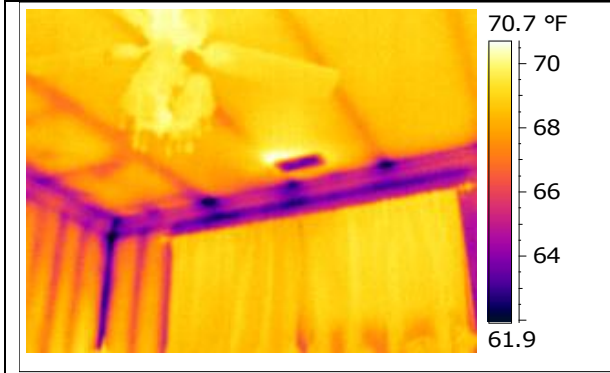
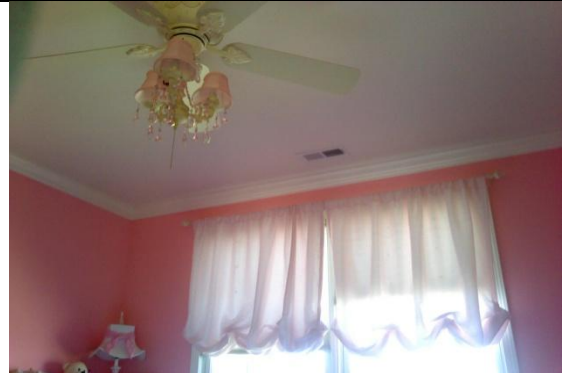
Image.File name IR\_1052.jpg

LOCATION: Rear Left Bedroom  
 WHERE: Wall and ceiling junction  
 CONDITION: The thermal pattern, darker areas, is indicative of missing insulation/air leakage  
 RECOMMENDATION: Installing additional insulation and air sealing is recommended  
 COMMENTS:

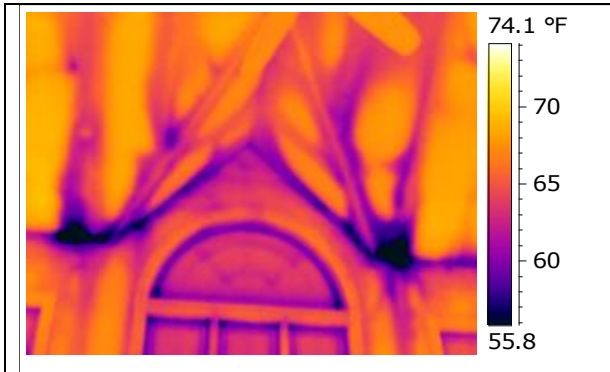
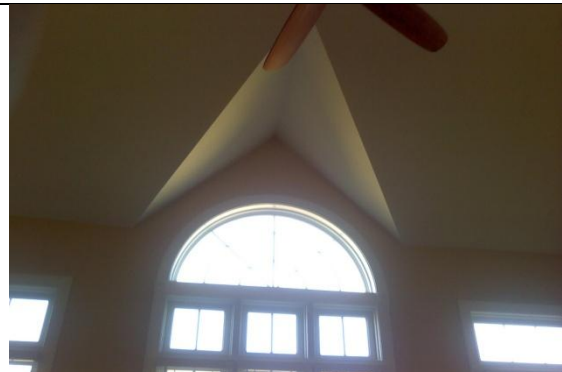
Image.File name IR\_1054.jpg

LOCATION: Family Room  
 WHERE: Ceiling  
 CONDITION: The thermal pattern, darker areas, is indicative of missing insulation/air leakage  
 RECOMMENDATION: Installing additional insulation and air sealing is recommended  
 COMMENTS:

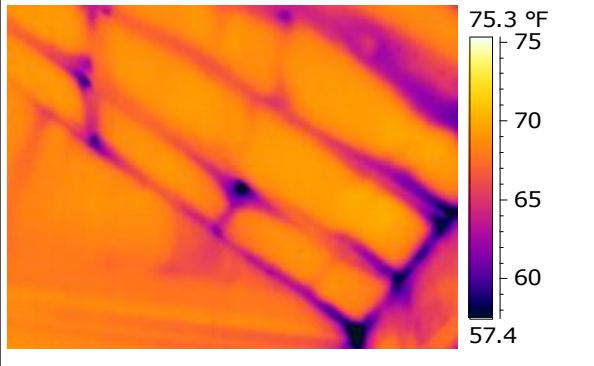
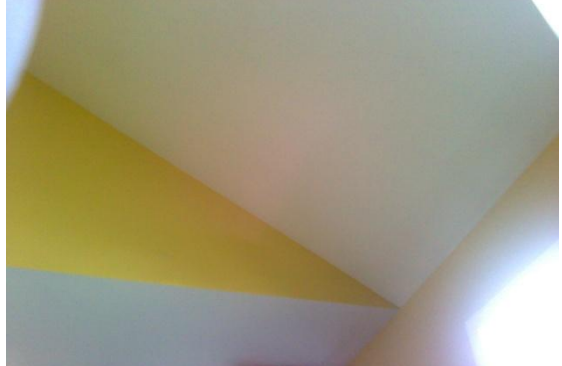
<b>Image.File name IR_1056.jpg</b>	<b>Image.Date 3/10/2012 Image.Time 10:38:36 AM</b>
<p>LOCATION: Family Room          WHERE: Ceiling          CONDITION: The thermal pattern, Darker areas, is indicative of insufficient/missing insulation          RECOMMENDATION: Suggest installing additional blown-in insulation to R-50          COMMENTS:</p>

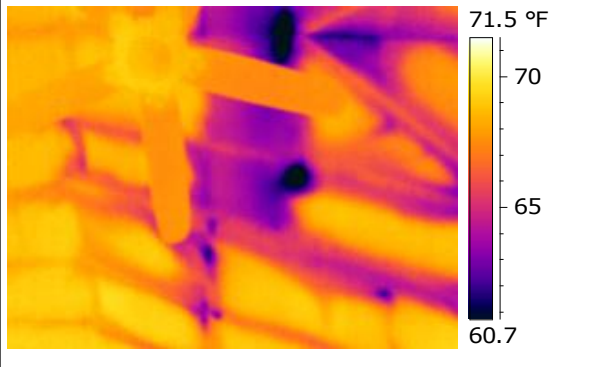
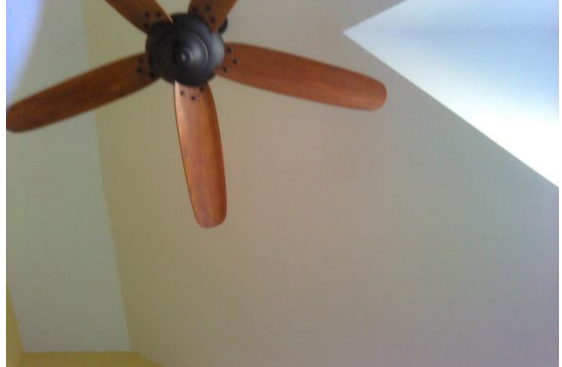
<b>Image.File name IR_1058.jpg</b>	<b>Image.Date 3/10/2012 Image.Time 10:39:15 AM</b>
<p>LOCATION: Family Room          WHERE: Ceiling          CONDITION: The thermal pattern, Darker areas, is indicative of insufficient/missing insulation          RECOMMENDATION: Suggest installing additional blown-in insulation to R-50          COMMENTS:</p>

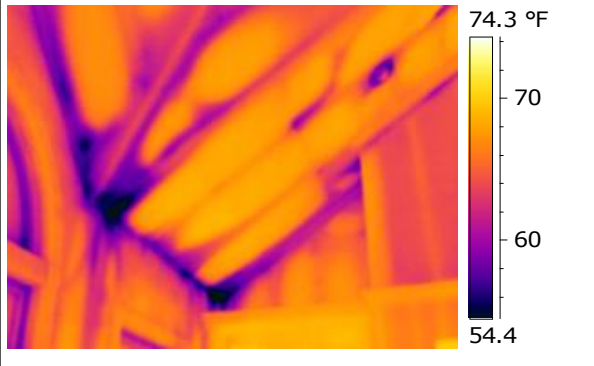
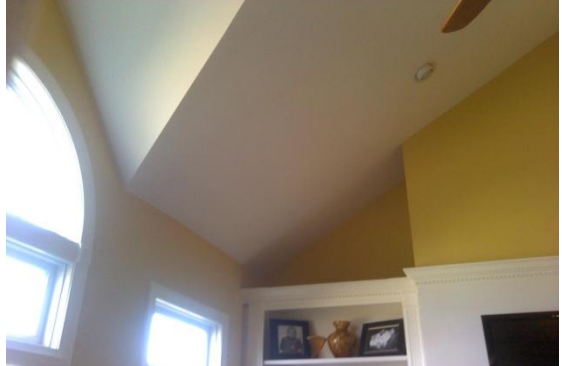
<p><b>Image.File name</b> IR_1060.jpg</p>	<p><b>Image.Date</b> 3/10/2012 <b>Image.Time</b> 10:39:52 AM</p>
<p>LOCATION: Family Room                  WHERE: Ceiling                  CONDITION: The thermal pattern, darker areas, is indicative of missing insulation/air leakage                  RECOMMENDATION: Installing additional insulation and air sealing is recommended                  COMMENTS:</p>

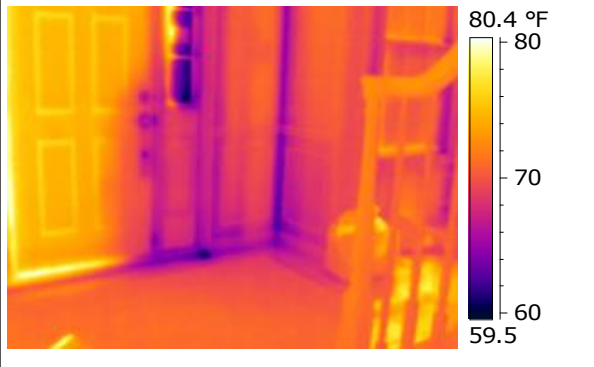
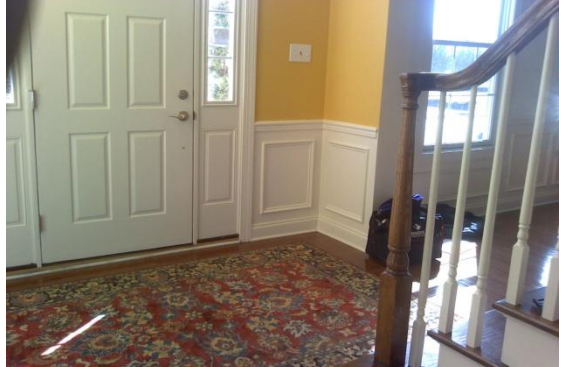
<p><b>Image.File name</b> IR_1062.jpg</p>	<p><b>Image.Date</b> 3/10/2012 <b>Image.Time</b> 10:41:15 AM</p>
<p>LOCATION: Entry                  WHERE: Door                  CONDITION: Air leakage                  RECOMMENDATION: Air sealing and upgrading door weatherstripping is recommended                  COMMENTS:</p>
