Infrared Energy Report

Rouser Way
Hillsborough, NJ 08844

Survey Information

Survey Report #: 20120311SAM
Survey date: 3/11/2012

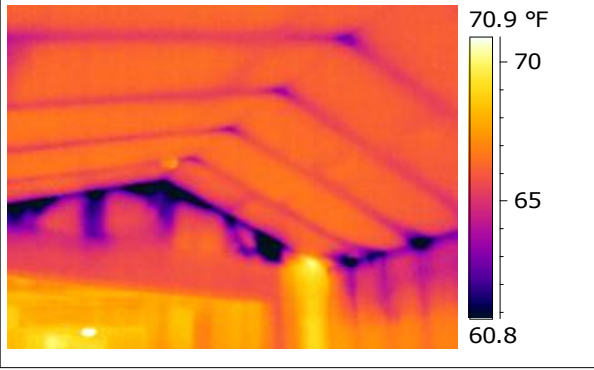
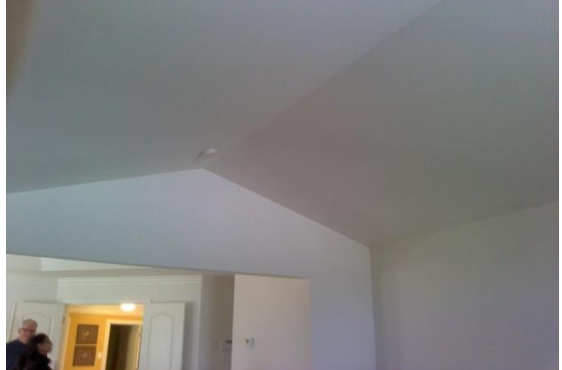
<p>Image.File name IR_1034.jpg Image.Date 3/10/2012 Image.Time 10:28:45 AM</p>	
<p>LOCATION: Master Bedroom WHERE: Wall and ceiling junction CONDITION: The thermal pattern, darker areas, is indicative of missing insulation/air leakage RECOMMENDATION: Installing additional insulation and air sealing is recommended COMMENTS:</p>

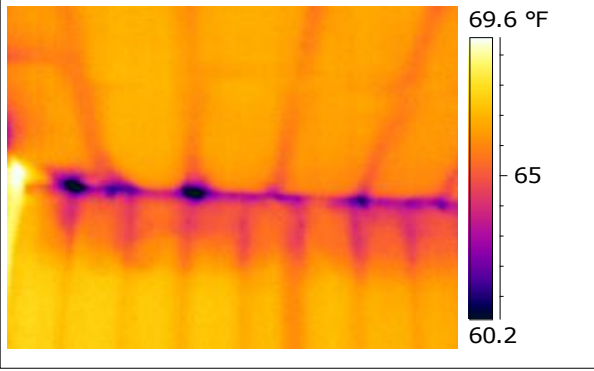
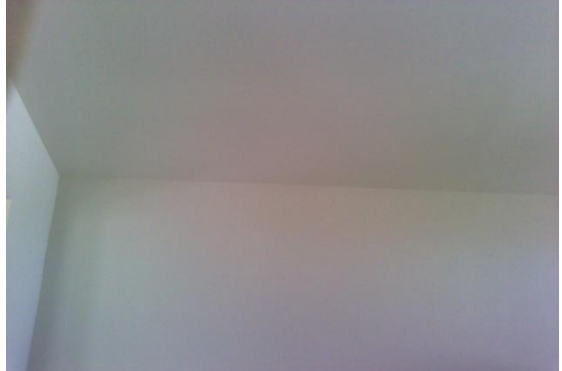
<p>Image.File name IR_1038.jpg Image.Date 3/10/2012 Image.Time 10:29:49 AM</p>	
<p>LOCATION: Master Bedroom WHERE: Wall and ceiling junction CONDITION: The thermal pattern, darker areas, is indicative of missing insulation/air leakage RECOMMENDATION: Installing additional insulation and air sealing is recommended COMMENTS:</p>

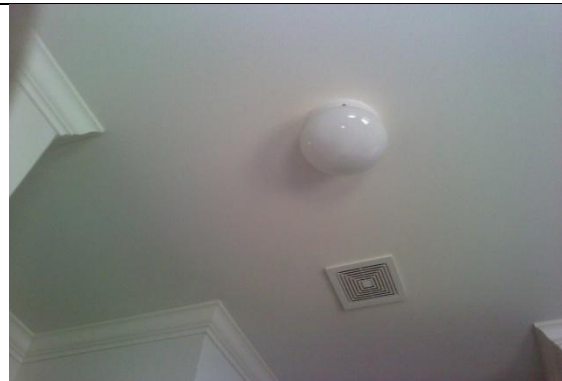
Image.File name IR_1042.jpg

LOCATION: Master bathroom
 WHERE: Ceiling
 CONDITION: The thermal pattern, Darker areas, is indicative of insufficient/missing insulation
 RECOMMENDATION: Suggest installing additional blown-in insulation to R-50
 COMMENTS:

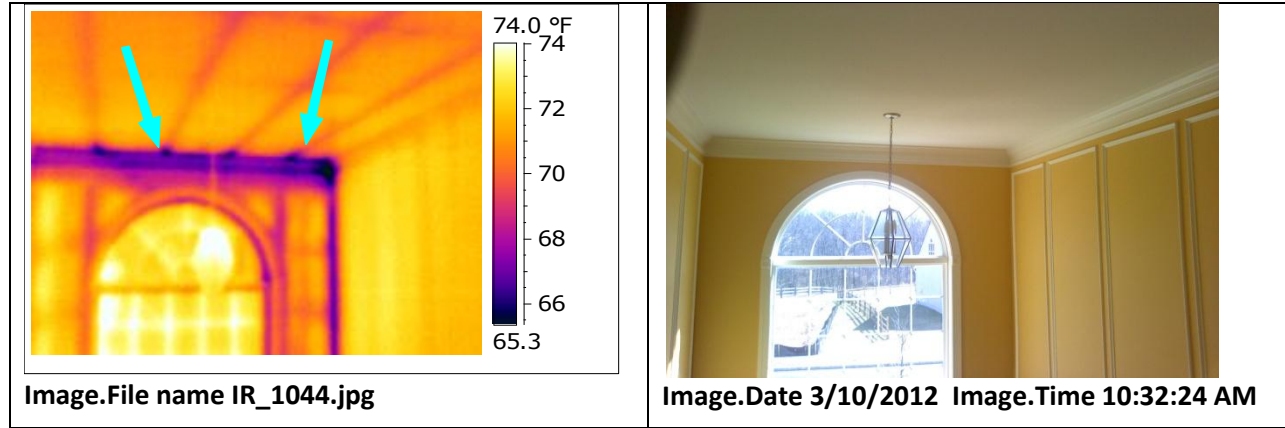
LOCATION: Entry
 WHERE: Wall and ceiling junction
 CONDITION: The thermal pattern, darker areas, is indicative of missing insulation/air leakage
 RECOMMENDATION: Installing additional insulation and air sealing is recommended
 COMMENTS:

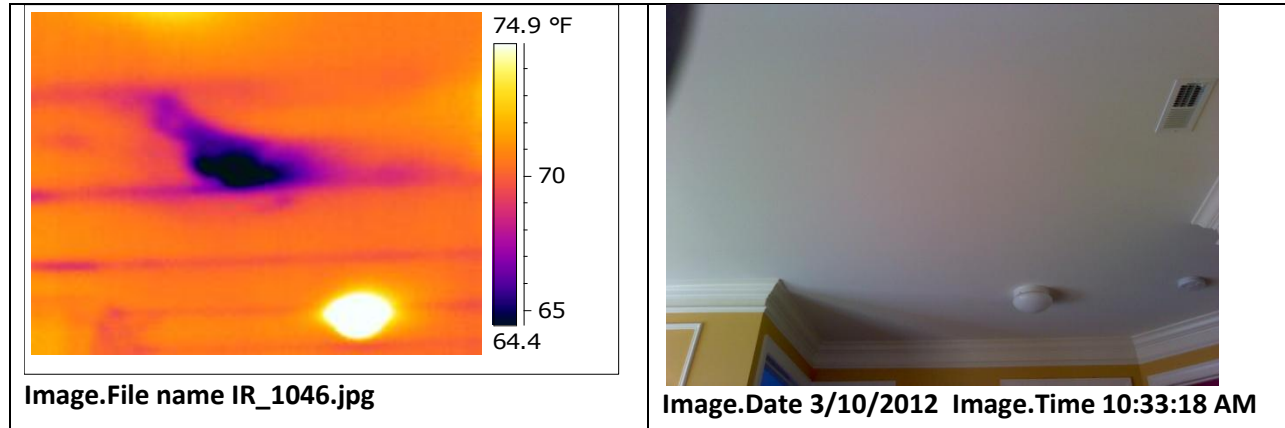
LOCATION: Hallway Upper
 WHERE: Ceiling
 CONDITION: The thermal pattern, darker areas, is indicative of missing insulation
 RECOMMENDATION: Suggest installing additional blown-in insulation to R-50
 COMMENTS:

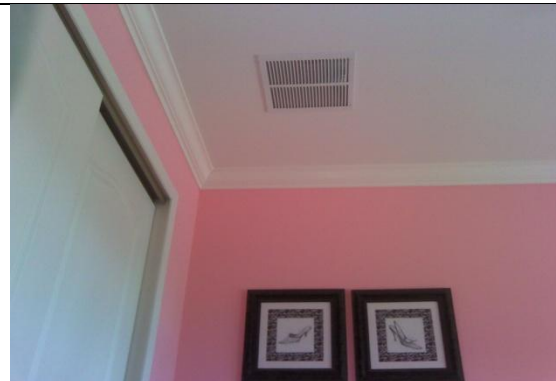
Image.File name IR_1050.jpg

LOCATION: Rear Left Bedroom

WHERE: Ceiling

CONDITION: The thermal pattern, darker areas, is indicative of missing insulation/air leakage

RECOMMENDATION: Installing additional insulation and air sealing is recommended

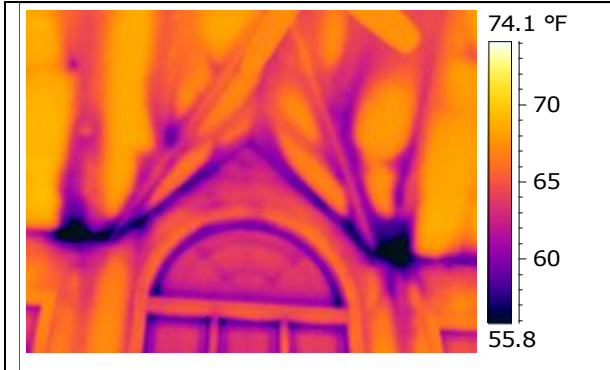
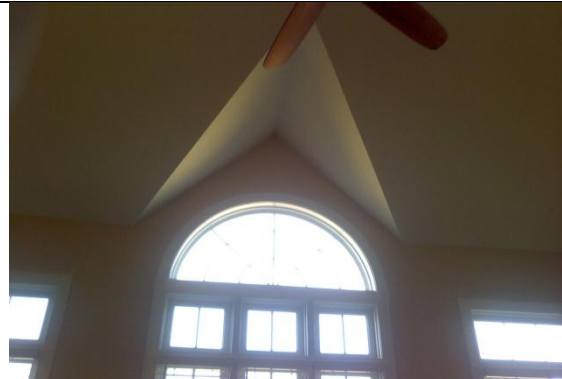
Image.File name IR_1054.jpg

LOCATION: Family Room
 WHERE: Ceiling
 CONDITION: The thermal pattern, darker areas, is indicative of missing insulation/air leakage
 RECOMMENDATION: Installing additional insulation and air sealing is recommended
 COMMENTS:

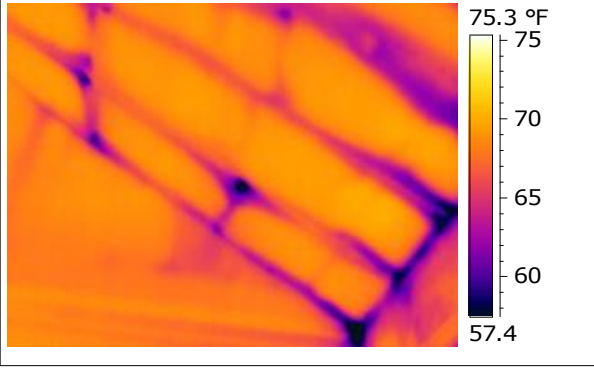
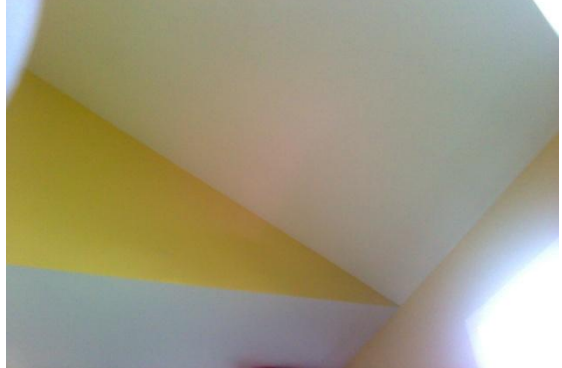
<p>Image.File name IR_1056.jpg</p>	<p>Image.Date 3/10/2012 Image.Time 10:38:36 AM</p>
<p>LOCATION: Family Room WHERE: Ceiling CONDITION: The thermal pattern, Darker areas, is indicative of insufficient/missing insulation RECOMMENDATION: Suggest installing additional blown-in insulation to R-50 COMMENTS:</p>

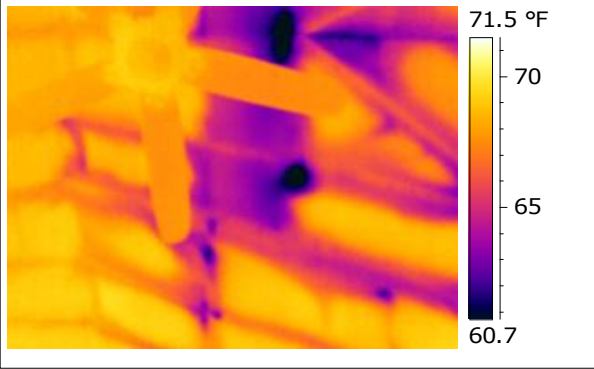
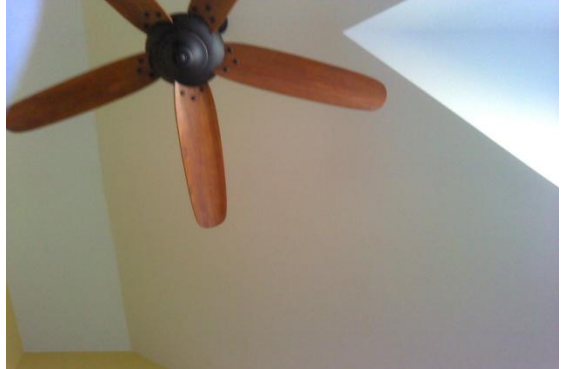
<p>Image.File name IR_1058.jpg</p>	<p>Image.Date 3/10/2012 Image.Time 10:39:15 AM</p>
<p>LOCATION: Family Room WHERE: Ceiling CONDITION: The thermal pattern, Darker areas, is indicative of insufficient/missing insulation RECOMMENDATION: Suggest installing additional blown-in insulation to R-50 COMMENTS:</p>

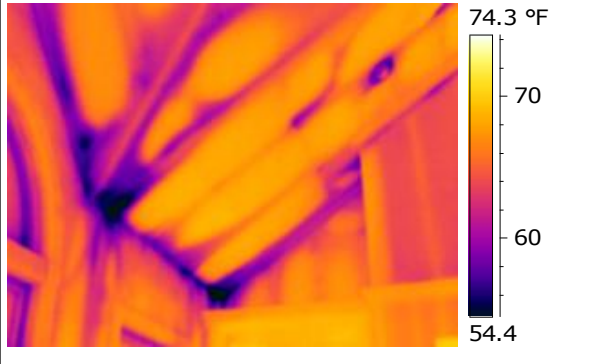
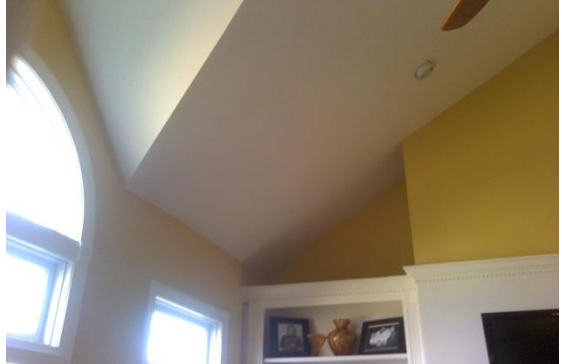
<p>Image.File name IR_1060.jpg</p>	<p>Image.Date 3/10/2012 Image.Time 10:39:52 AM</p>
<p>LOCATION: Family Room WHERE: Ceiling CONDITION: The thermal pattern, darker areas, is indicative of missing insulation/air leakage RECOMMENDATION: Installing additional insulation and air sealing is recommended COMMENTS:</p>

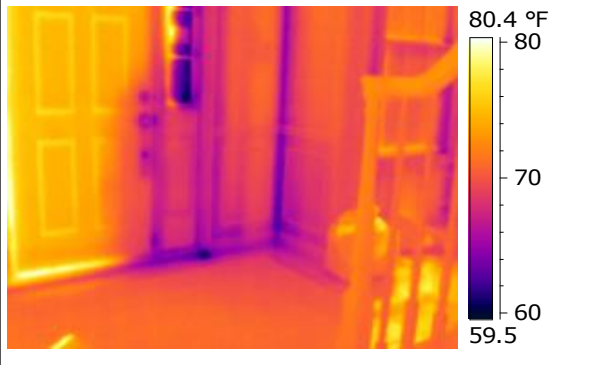
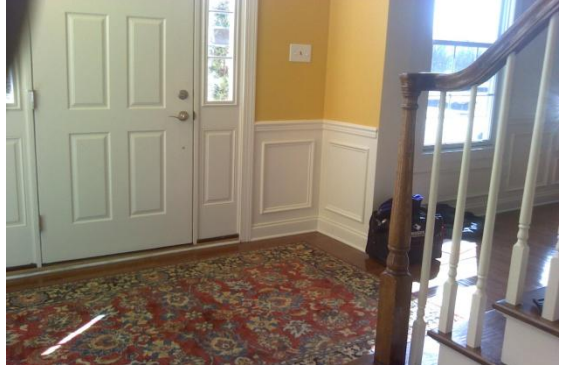
<p>Image.File name IR_1062.jpg</p>	<p>Image.Date 3/10/2012 Image.Time 10:41:15 AM</p>
<p>LOCATION: Entry WHERE: Door CONDITION: Air leakage RECOMMENDATION: Air sealing and upgrading door weatherstripping is recommended COMMENTS:</p>
